## Sound Practice No.1

# Increasing Storm Water Drainage Capacity of Mithi River and Mumbai City drains

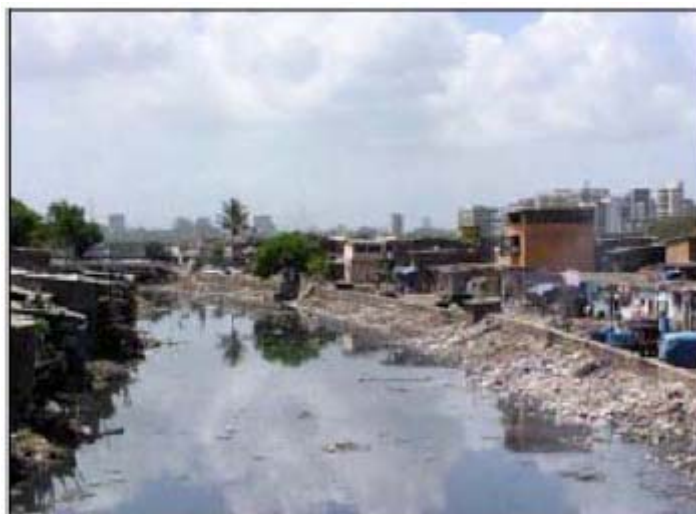
**Source:** Report on Mithi River Water Pollution by “Klean Environmental Consultants Pvt Ltd.”, July 2004, prepared for Maharashtra Pollution Control Board Photographs # 7 and #11

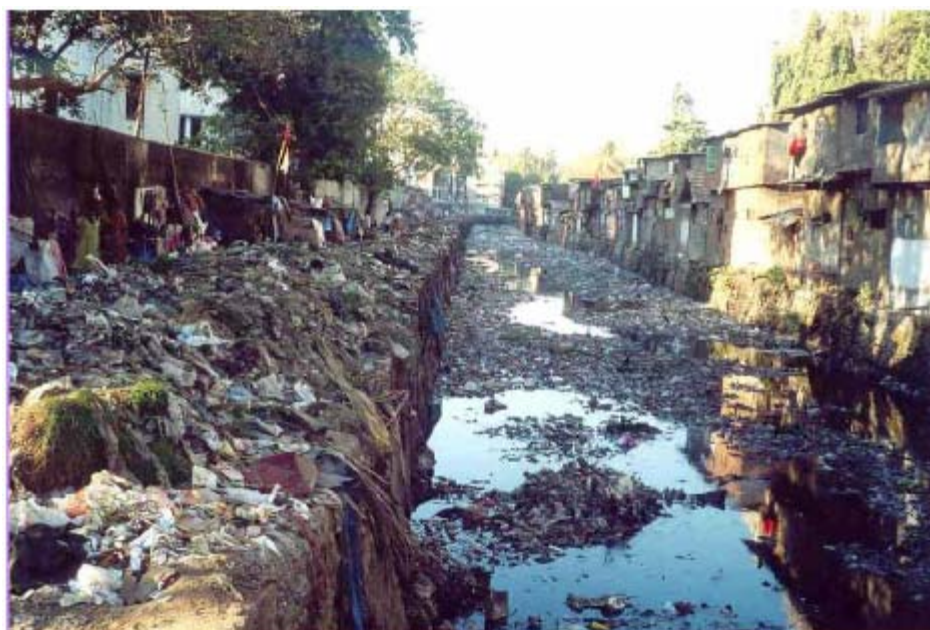
**Source:** A Report titled “Urban Flooding: Vulnerability, Preparedness and Mitigation – 944 mm Mumbai 26/07/2005 event” by Prof. Kapil Gupta of IIT Bombay presented at International Centre for Excellence in Water Resources Management
